RESPONSES OF BURIED CORRUGATED METAL PIPES TO EARTHQUAKES

By C. A. Davis¹ and J. P. Bardet,² Members, ASCE

ABSTRACT: This study describes the results of field investigations and analyses carried out on 61 corrugated metal pipes (CMP) that were shaken by the 1994 Northridge earthquake. These CMPs, which include 29 small-diameter (below 107 cm) CMPs and 32 large-diameter (above 107 cm) CMPs, are located within a 10 km² area encompassing the Van Norman Complex in the Northern San Fernando Valley, in Los Angeles, California. During the Northridge earthquake, ground movements were extensively recorded within the study area. Twenty-eight of the small-diameter CMPs performed well while the 32 large-diameter CMPs underwent performances ranging from no damage to complete collapse. The main cause of damage to the large-diameter CMPs was found to be the large ground strains. Based on this unprecedented data set, the factors controlling the seismic performance of the 32 large-diameter CMPs were identified and framed into a pseudostatic analysis method for evaluating the response of large diameter flexible underground pipes subjected to ground strain. The proposed analysis, which is applicabl

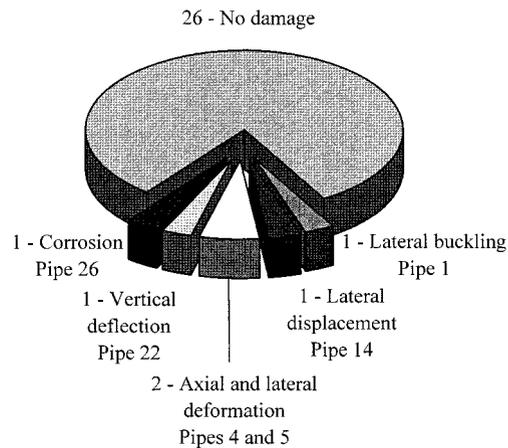
FIG. 7. Distribution of Observed Damage from 1994 Northridge Earthquake

shown in Fig. 7 and Table 1, six CMPs (i.e., 1, 4, 5, 14, 22, and 26) underwent five forms of damage and significant deformation after the 1994 Northridge earthquake. Prior to that earthquake, Pipes 1, 4, 5, and 14 were in good operating condition but Pipe 22 had deformed vertically and Pipe 26 was corroded. Pipe 22 had a deflected shape similar to pipes embedded in poorly compacted soils (Moser 1990). The joints of Pipes 15 and 16 partially separated because of beam-type bending caused by foundation and embankment deformations. However, the concrete surrounding these pipes remained intact and largely contributed to their good performance. As noted in Table 1, there was no evidence that Pipe 23 deformed because of the Northridge earthquake. The pipes that could not be accessed or thoroughly inspected (i.e., quality C and D) were considered to be undamaged based on the absence of (1) reported damage from local highway officials (Youd and Beckman 1996) and (2) surface deformations above these pipes. However, the lack of reported or surficial evidence is not con-

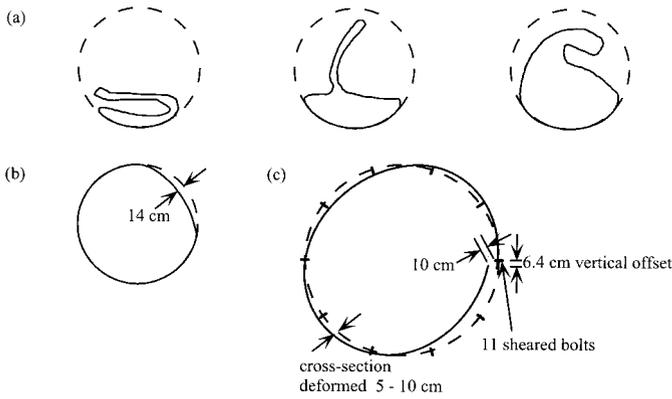
FIG. 8. Deformed CMP Shapes: (a) Pipe 1; (b) Pipe 4; and (c) Pipe 5

Figs. 8(a–c) show damaged sections of Pipes 1, 4, and 5, respectively—results of the 1994 earthquake. Pipe 1 suffered complete lateral collapse. Pipe 4 sustained transverse deformations measuring up to 14 cm. Eleven 19-mm diameter bolts were sheared along the spring line of Pipe 5W, which allowed 10 cm of lateral separation and 6.4 cm of vertical shortening. In addition, as shown in Fig. 8(c), the diameter of Pipe 5 was permanently distorted by up to 20 cm along a 18 m length. Longitudinal buckling also occurred in Pipes 4 and 5, whereas no axial deformations were observed on Pipe 1. As a result of limited soil movement, damage to Pipe 14 was more superficial than structural, causing minor deformations of the shell and spalling of the tar coating. Vertical deflection of Pipe 22 existed prior to the Northridge earthquake and was enhanced by settlement of the embedding soils during shaking. Buckling of Pipe 26 was clearly related to severe corrosion of the invert.

Three other factors were identified as particular sources of damage to Pipes 14, 22, and 26, respectively: (1) permanent ground deformation; (2) settlement of poorly compacted embedding soils (construction method not meeting current standards); and (3) corrosion. In contrast, causes of damage to Pipes 1, 4, and 5 were not readily apparent from the field investigations.

The strain-based analysis indicates that the large transient velocities recorded in the VNC damaged Pipes 1, 4, and 5 and that permanent ground strains were not necessary for damage to occur. Combining these results with Pipe 14, it is concluded that the main cause of damage to large-diameter CMP is large ground strain resulting from transient and/or permanent ground deformation.

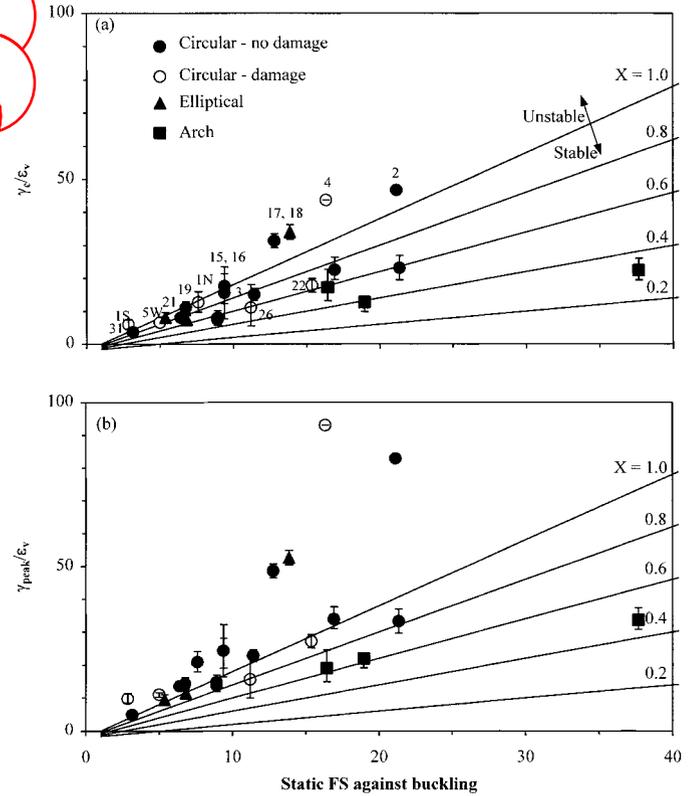
FIG. 11. Results of Strain-Based Analysis for Large-Diameter Pipes for $\beta = 1$ and Shear Strain Calculated Using (a) Transverse Peak Ground Velocity (pgv_2); and (b) Horizontal Peak Ground Velocity (pgv_{12})

Fig. 11(a) shows the minimum strain ratio required to cause buckling for values of X ranging from 1 to 0.2. Fig. 11(a) also shows the range of strain ratios calculated for each pipe from (3) and (6) with the range of pgv_2 values shown in Fig. 6(d). For a given value of X , the pipe is stable when the point (FS , γ_c/ϵ_v) is below the straight line defined in (12) and unstable above that line. Although the analysis strictly applies only to circular sections, elliptical and arch sections are included in Fig. 11 for comparative purposes. The FS for some shallow buried pipes are beyond the scale provided in Fig. 11. Fig. 11(a) predicts the buckling of Pipes 1S and 4 during the 1994 Northridge earthquake, without the need for a reduction in buckling strength (i.e., $X = 1$). In addition, with a slight reduction in buckling strength (i.e., $X = 0.8$ to 0.9), Fig. 11(a) predicts the buckling of Pipes 1N and 5W. At the same time, Fig. 11(a) indicates that Pipes 2, 3, 17E, 18E, 19, 21, and 31 were to buckle during the earthquake. Fig. 11(a) also shows that Pipes 22 and 26 may not have been damaged if they were properly constructed and maintained and that Pipes 15 and 16, which were submerged below the ground water, may have suffered significant damage if they were not concrete encased. Variation between actual and predicted performance is expected considering that the conditions for each pipe have been approximated in the analysis. Changes in stiffness of the underlying and embedding soils can provide significant changes in the results of Fig. 11(a). In addition, the analysis is sensitive to the orientation of the pipe with respect to the direction of fault rupture. This directional effect is clearly demonstrated by comparing the buckling analysis results of Figs. 11(a) and (b). In Fig. 11(a), γ_c was determined from pgv_2 , the peak velocity oriented transverse to the pipe, whereas in Fig. 11(b), γ_{peak} was calculated from pgv_{12} , the peak ground velocity in the horizontal plane. As shown in Fig. 5, pgv_2 varies with azimuth while pgv_{12} occurs at a particular angle θ_{12} . The use of pgv_2 results in a good correlation with the field performance, whereas the use of pgv_{12} indicates that most all the pipes had to buckle. Table 5 shows that θ_{12} varied across the VNC by as much as 45° , which can significantly influence the analysis results. For example, a 10° variation of θ_{12} , such as that between Stations 5 and 7, could reduce the results of Pipes 17W and 18W by 21%, which is enough to lower the points (FS , γ_c/ϵ_v) in Fig. 11(a) near the $X = 1$ line. The analyses presented herein estimate an upper-bound hoop force because they as-

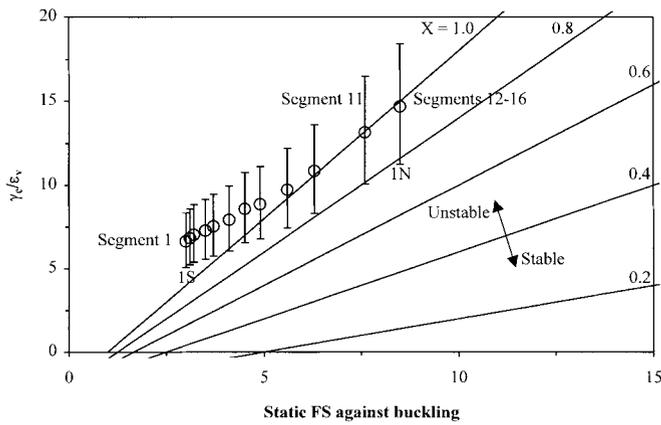
FIG. 12. Results of Strain-Based Analysis for 16 Separate Segments of Pipe 1

Fig. 12 shows the range of strain ratios for each individual segment of Pipe 1. The pipe segments, which are numbered from 1 to 16, undergo changes in static loads due to the change in fill depth above Pipe 1 (Davis and Bardet 1998). Segment 1 corresponds to Pipe 1A in Fig. 11, and segments 12–16 correspond to Pipe 1N in Fig. 11. As shown in Fig. 12, it is possible to conclude that segments 1 to 6 failed for $X = 1$ during the Northridge earthquake. For other segments to fail, only a slight reduction in E was necessary during dynamic loading (i.e., $0.8 < X < 1$). This reduction may have been caused by the buildup of pore pressure in the embedding material, without the need for complete liquefaction (i.e., $X = 0$), or by the modulus degradation with strain of unsaturated embedding soils. Fig. 12 implies that the strain-based analysis can be applied not only to pipes as a whole but also to individual segments along the pipe length.
