RESPONSES OF BURIED CORRUGATED METAL PIPES TO EARTHQUAKES

By C. A. Davis¹ and J. P. Bardet,² Members, ASCE

ABSTRACT: This study describes the results of field investigations and analyses carried out on 61 corrugated metal pipes (CMP) that were shaken by the 1994 Northridge earthquake. These CMPs, which include 29 small-diameter (below 107 cm) CMPs and 32 large-diameter (above 107 cm) CMPs, are located within a 10 km² area encompassing the Van Norman Complex in the Northern San Fernando Valley, in Los Angeles, California. During the Northridge earthquake, ground movements were extensively recorded within the study area. Twenty-eight of the small-diameter CMPs performed well while the 32 large-diameter CMPs underwent performances ranging from no damage to complete collapse. The main cause of damage to the large-diameter CMPs was found to be the large ground strains. Based on this unprecedented data set, the factors controlling the seismic performance of the 32 large-diameter CMPs were identified and framed into a pseudostatic analysis method for evaluating the response of large diameter flexible underground pipes subjected to ground strain. The proposed analysis, which is applicabl

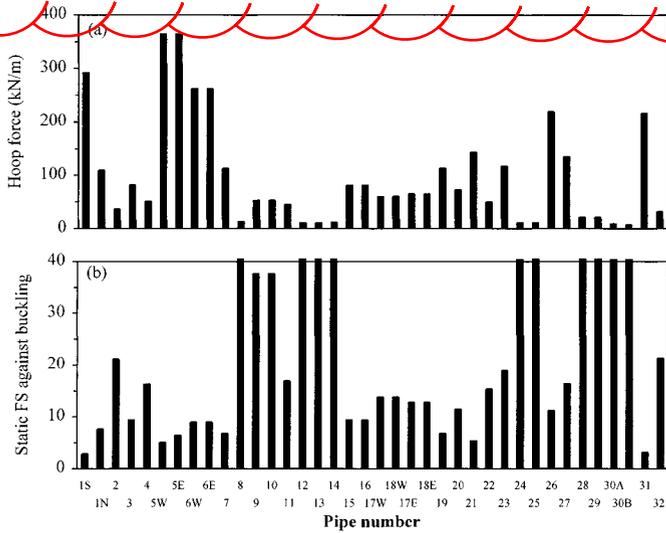
FIG. 9. Results of Static Analysis: (a) Estimated Hoop Force for Arching Factor $\beta = 1$; (b) Estimated Static Factor of Safety FS against Buckling

Fig. 9(b) shows the calculated static factors of safety FS against buckling for all the 32 large-diameter pipes. For all pipes FS is greater than 2. As shown in Fig. 9(b), FS becomes very large for some shallow pipes and even exceeds 100 in some cases. These large values are expected because our calculations account only for the fill overburden, and they neglect the surcharges and traffic loads that were used in the original design of these pipes. In conclusion, all CMPs were stable under static soil loads.
